**Fatigue Behavior of a Quasi-Isotropic  
Graphite/Epoxy Laminate Embedded with a  
Piezoelectric Sensor**

**Thesis**

**Jon M. Coleman B.S.M.E., M.B.A.  
Captain, USAF**

Presented to the Faculty of the Graduate School of Engineering of the Air Force Institute of  
Technology Air University In Partial Fulfillment for the Degree of

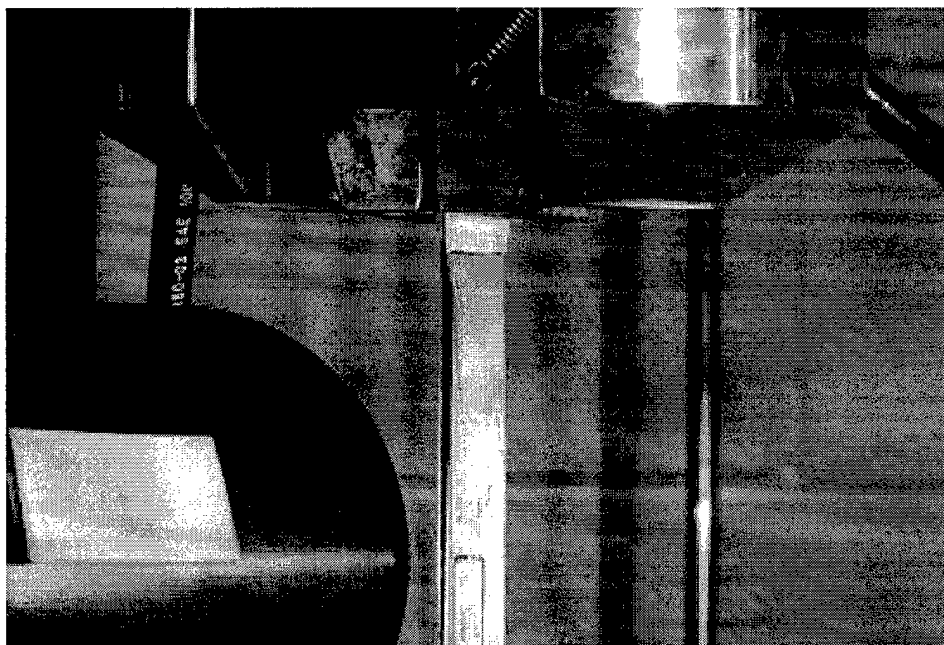
Figure 47. Edge View of AT2 at 500k Cycles
